Heavy metal residue in the landfill area of Tan Deaw sub-district in Saraburi and in adjacent areas

Thailand Institute of Scientific and Technological Research (TISTR) monitors the number of heavy metal residues in soil, surface water, and plants in landfill areas of Tan Daew sub-district, Kaeng Khoi district, Saraburi province for every 3 months from February 2018 to February 2019. The highest levels of heavy metal residues in the soil are found including manganese, lead, and arsenic, averagely at 1,083.00, 22.82 and 4.45 milligrams per kilogram, respectively, which are not exceeding the soil quality standards for living and agriculture except in February and November 2018, where the detection of manganese and arsenic exceed the standard criteria. For heavy metals in the water, a total of 6 elements are found with the value of that are not exceeding the surface water quality standard of type 3. In addition, manganese accumulation is detected in giant Mimosa Pudica plant in the landfill area either in leaves and stems at the amount of 0.14 and 0.05 times the amount of soil residue. And when analyzing the amount of heavy metal residue in soil and water in public areas that is appro

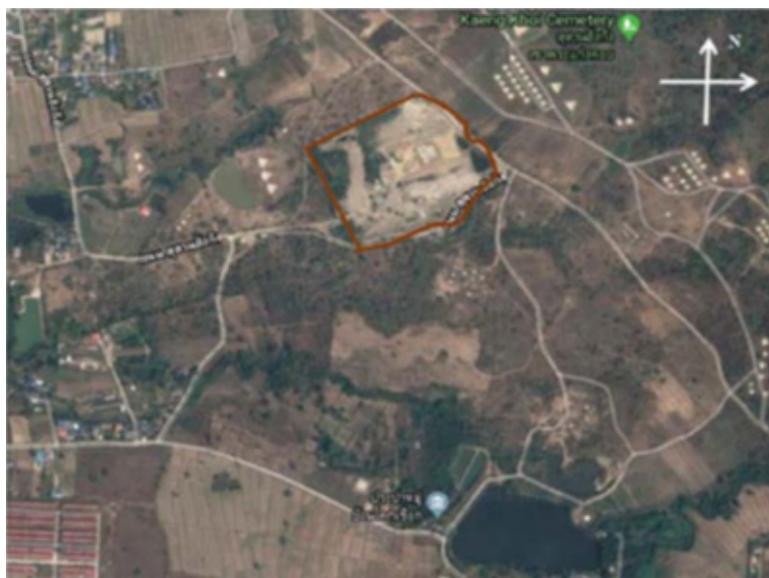
Figure 1 Map of sampling sites; 1) Municipal dumping site; 2) Public area; 3) Municipal water source

Samples are collected from 3 study areas including (1) landfill site of Tan Daew Sub-district, Kaeng Khoi District, Saraburi Province (2) public areas and (3) tap water production sources with the distance of 300 and 630 meters away from the landfill site, respectively. The coordinates at all sampling sites (Figure 1 and Table 1) are recorded. Soil and surface water samples are collected every 3 months between February 2018
